IN THE MATTER OF THE APPLICATION OF CHAPARRAL CITY WATER COMPANY FOR A DETERMINATION OF THE CURRENT FAIR VALUE OF ITS UTILITY PLANT AND PROPERTY AND FOR INCREASE IN ITS RATES AND CHARGES BASED THEREON – A SYSTEM IMPROVEMENT BENEFITS SURCHARGE PLAN OF ADMINISTRATION

DOCKET NO. W-02113A-13-0118

NOTICE OF COMPLIANCE FILING

### Chaparral City Water Company, PWSID No. 07-017 System Improvement Benefits SIB Progress Report Revised March 9, 2015

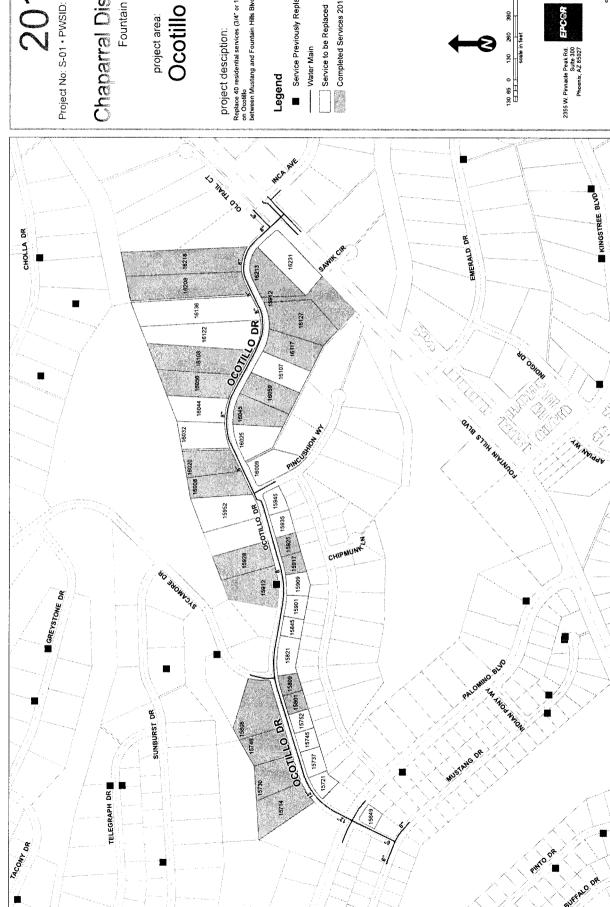
Project No: S-01 • PWSID: 07-017

project desciption:
Replace 4D residential services (3/4" or 1")
on Ocosilio
between Mustang and Fountain Hills Blvd.

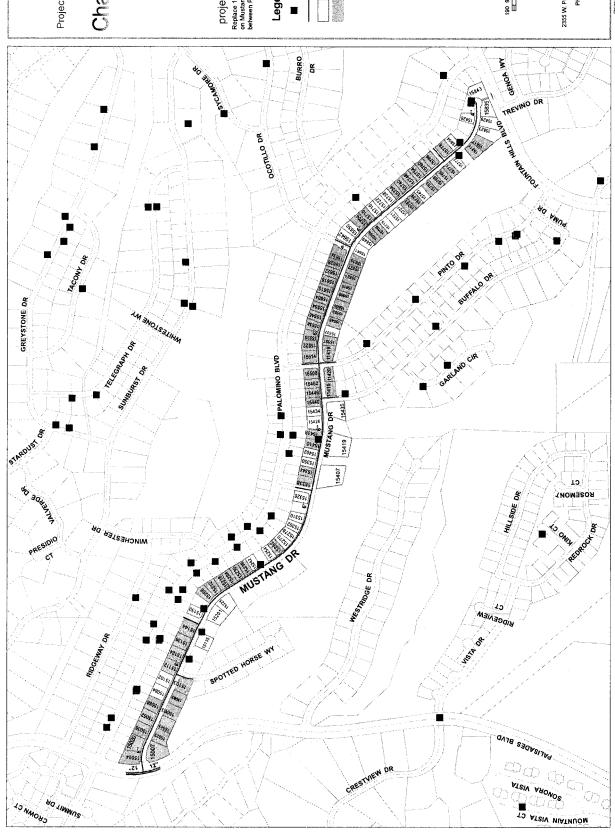
# 2014 Project No: S-02 • PWSID: 07-017

project desciption: Replace 105 residential services (34" or 1") on Mustang between Palisades and Fountain Hils Blvd.

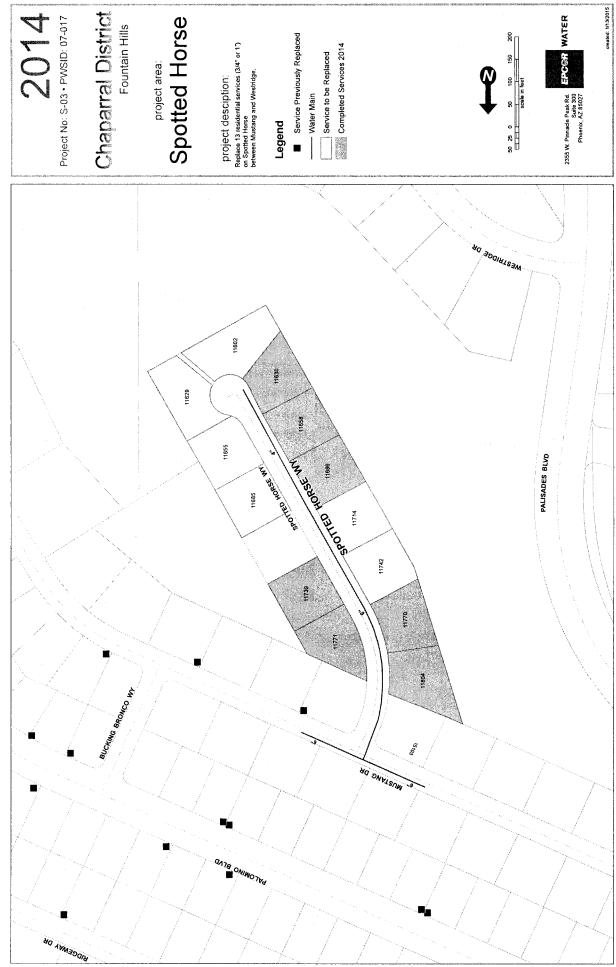
project desciption:
Replace 13 residential services (3/4" or 17)
on Sported Horse
between Mustang and Westridge.

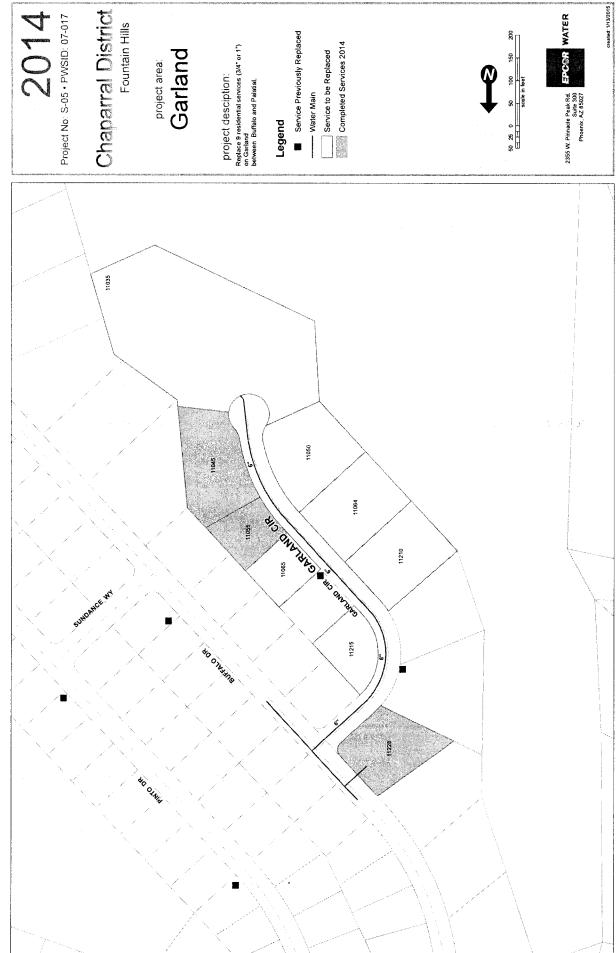
### project area: **Garland**

project desciption:
Replace 9 residential services (3/4\* or 1\*)
on Galland
between Buffalo and Palatial.

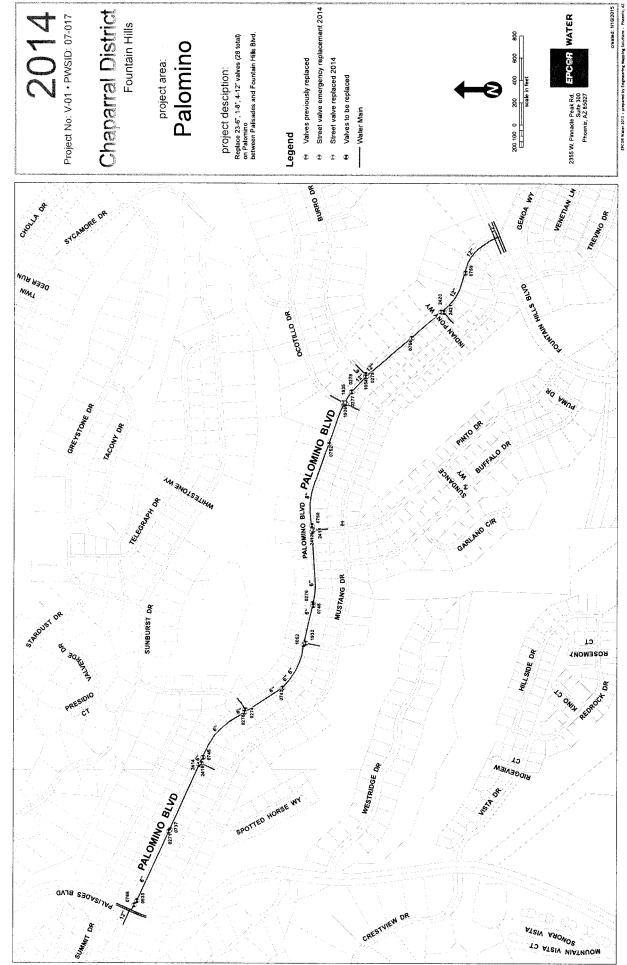
project desciption: Replace 23-5", 1-8", 4-12" valves (28 total) on Palomino between Palisades and Fountain Hills Blvd.
